THE RECOVERY, RECONSTRUCTION, AND ANALYSIS OF YENİKAPI 14 (YK
14), A MIDDLE BYZANTINE MERCHANT SHIP FROM THE THEODOSIAN
HARBOR EXCAVATIONS AT YENİKAPI, ISTANBUL

A Dissertation

MICHAEL RICE JONES

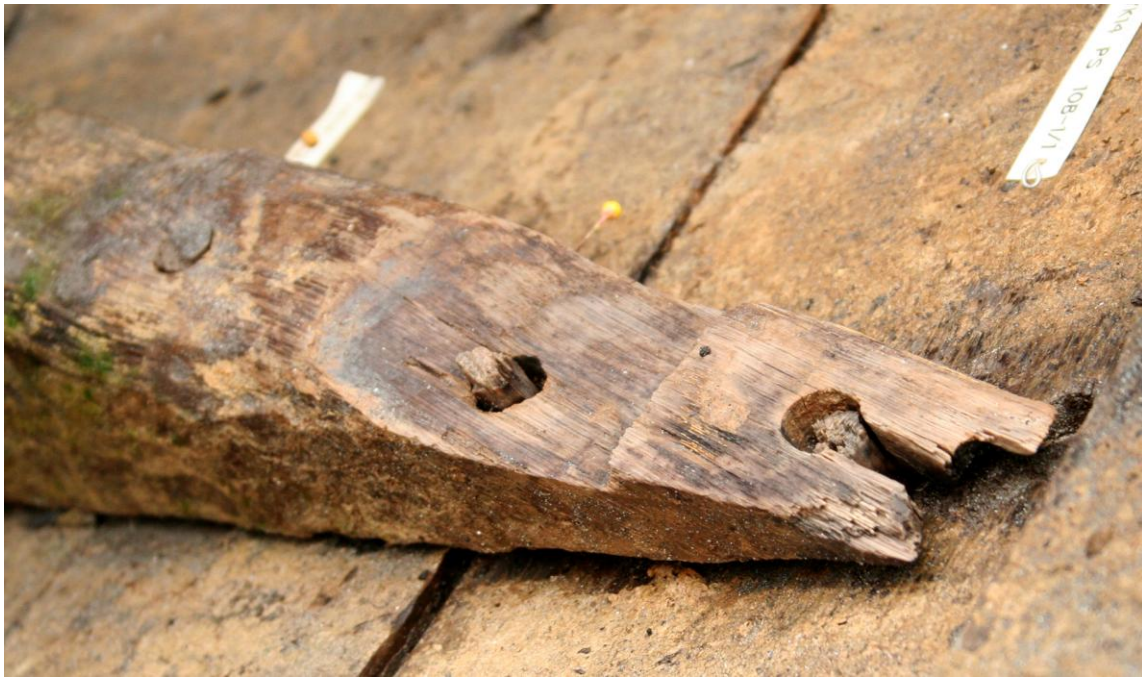
Figure 3.178: Oblique view of the hook scarf on the starboard end of FL 44.

Several features of FL 44 and its location in the hull are unique, suggesting its possible origin as a repair component. FL 44 is the only floor timber with scarfs on both its port and starboard ends. The port end is cut into a somewhat crude L-shaped floor/futtock similar to those seen on nearly all of the other surviving floor timbers, while its starboard end terminates in a 17 cm-long hook scarf, the only one of its kind used in the ship on frame timbers; this scarf joined futtock F 44, now lost (**Figures 3.177-78**). FL 44 is the only frame from YK 14 with no sawn faces; all of its faces were worked with an adze. A

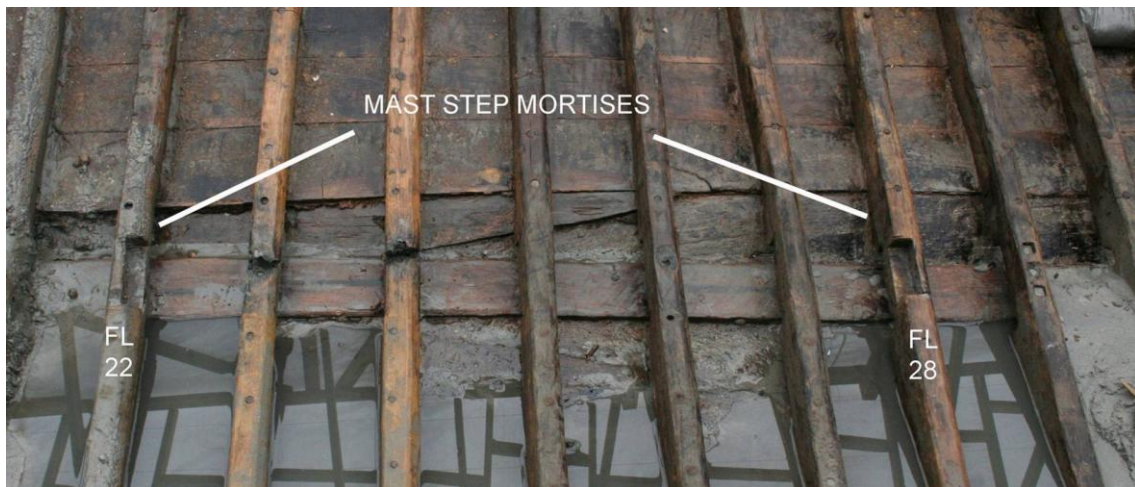
Figure 3.179: Mast step mortises in FL 22 and FL 28.

FL 22 and 28 each have mortises cut out of one side of the inner face of the frame over the keel (**Figure 3.179**). On FL 22, the notch is 13.0-13.3 cm long, 3.4-3.6 cm wide, and 3.1 cm deep, and is cut into the inner face/forward face edge of the frame. On FL 28, the mortise is 11.7 cm long, 2.7-3.7 cm wide and 3.8-3.9 cm deep, and cut into the inner face/aft face edge of the frame (**Figure 3.180**). These mortises were cut for the ship's mast step, and their placement give a minimum length for this timber of approximately 1.39 m (see Chapter V for a reconstruction of this timber). Like the mast steps from most of the Yenikapı shipwrecks, YK 14's mast step was not nailed to the floors; for this reason, it probably floated away during the ship's sinking, or was salvaged soon afterwards. No evidence for a mast partner was found in the hull in this area, but the

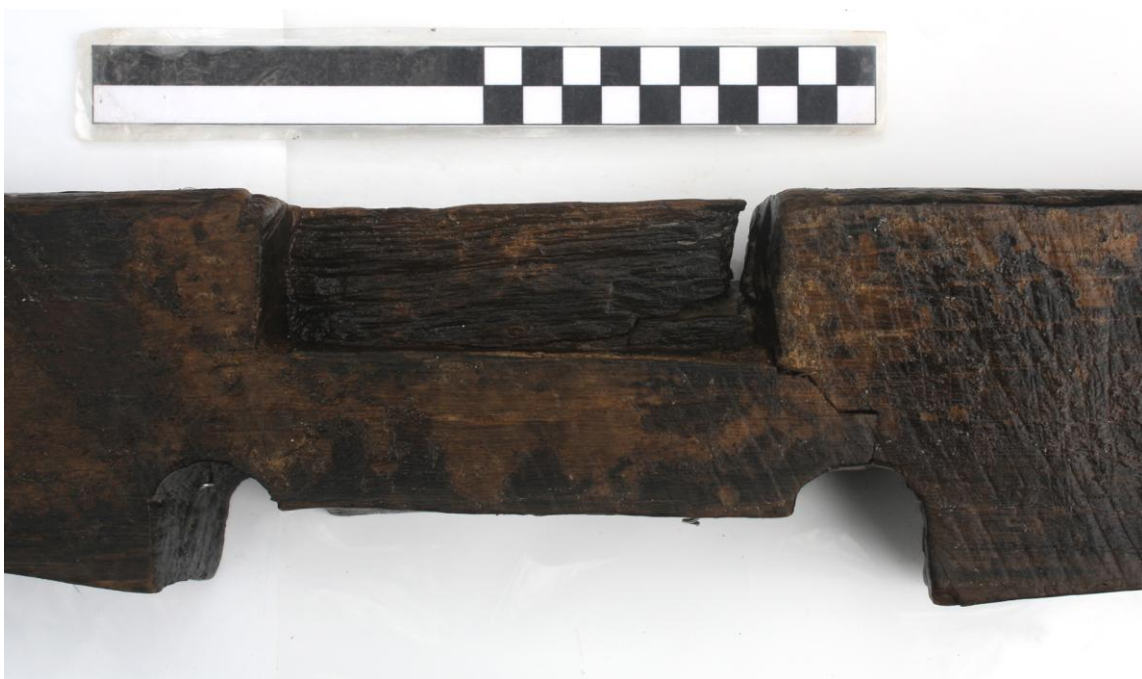
Figure 3.180: Detail of the mast step mortises in FL 28.

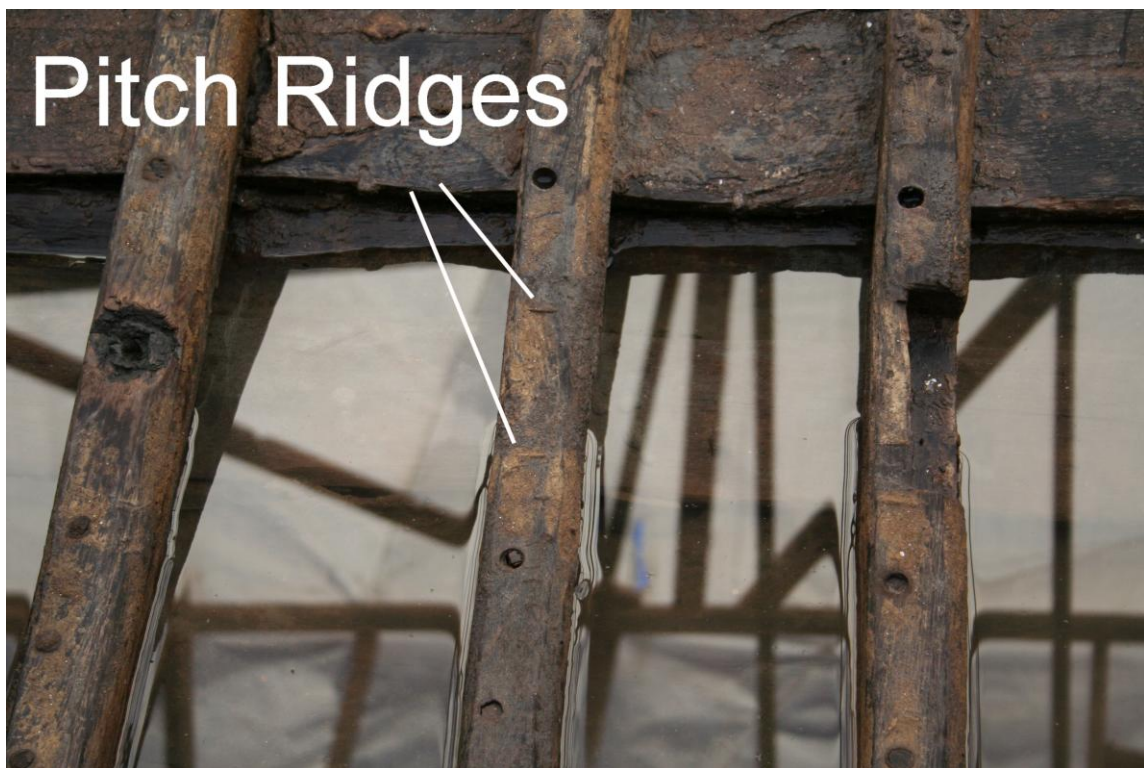
Figure 3.181: Pitch ridges on either side of the keel area of FL 21 (center), suggest that the mast step extended beyond the mortise in FL 22 at right. This feature was washed off the timber over the course of the excavation.

In an excavation photo of the floors FL 21-23, two parallel ridges appear on the inner face of FL 21 over the keel area. These impressions appear to be pitch ridges on the inner face of the floor built up at the original edges of the mast step's location, and indicate that the mast step may have extended beyond the mortises in FL 22 and 28 (**Figure 3.181**). No such feature is visible in the post-excavation photographs of the timber or was observed during the drawing and cataloging of the frame, probably because the pitch was washed off during the excavation.

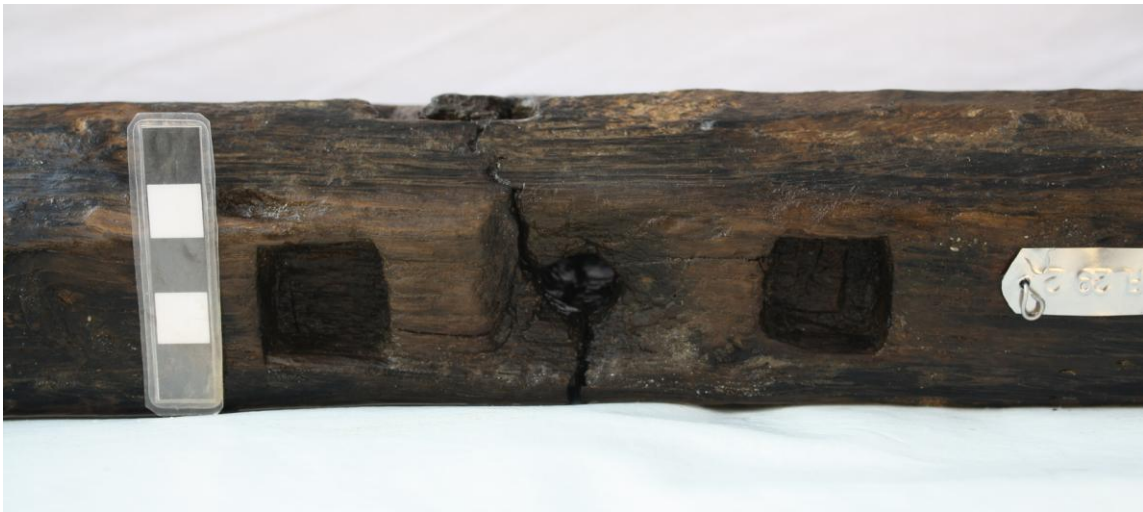
Figure 3.182: Mortises for stanchions on the inner face of FL 29, located over the keel area. A drilled hole and a countersinking for the keel nail head is visible between the mortises).

Pairs of mortises occurring in floors FL 29, 32, and 37 over the keel are most likely intended for inserting stanchions at these locations (**Figure 3.182**). The mortises are roughly square in section, 2.2-2.7 cm to a side, and 1.2-2.0 cm deep. They were cut on either side of the location of a keel nail on FL 29 and FL 32. The lower ends of the stanchions were not fastened to the floor timbers with treenails or nails.

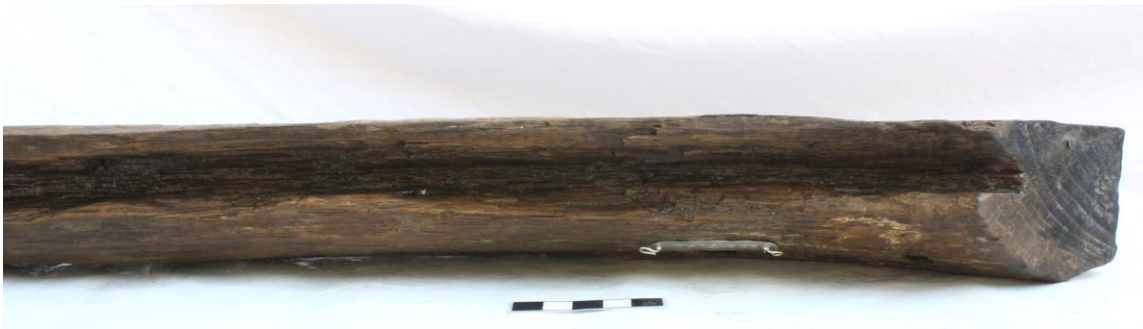
Figure 3.183: Groove cut in the inner face of F 29 for a bulkhead.

At FL 29 and FL 32, the stanchion mortises correspond to the locations of through-beam holes cut into PS 14 just aft of the futtocks F 29 and F 37. These futtocks have grooves cut into their inner faces with chisels, presumably for planks forming a removable bulkhead (**Figures 3.183-84**). The grooves in the inner faces of F 29 and F 37 are 1.5-2.5 cm wide, which indicates that the bulkhead planks were likely at least 1.0-1.5 cm thick, although the ends could have been thinned to fit in the groove. A roughly-cut depression

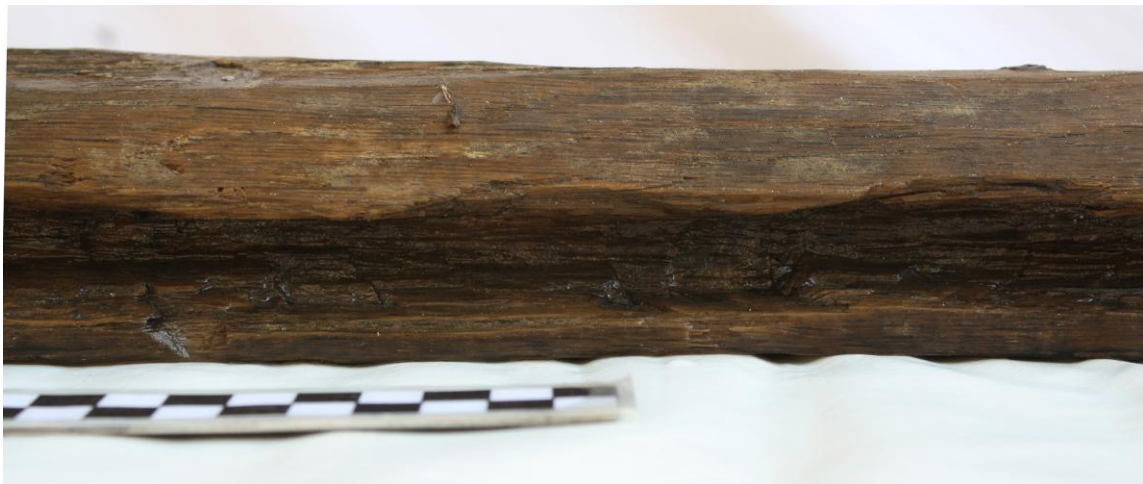
Figure 3.184: Detail of the groove cut in the inner face of F 29.

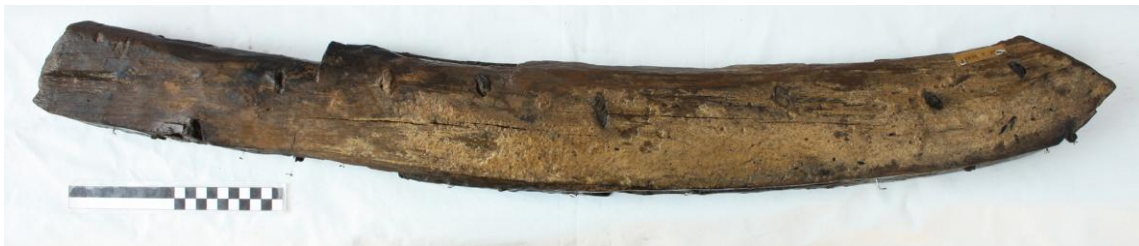
Figure 3.185: The forward face of F 29, a futtock with a groove in its forward face for a bulkhead. Note the angled treenails which were cut flat on the timber's forward face.

in the aft face of F 29 in the PS 13-14 area apparently accommodated a through-beam, which may have already been inserted at the time F 29 was installed. The bulkhead futtocks were fastened to the hull primarily with treenails; they were driven into drilled holes that had been angled towards the forward face of F 29 and towards the sawn aft face of F 37 in order to avoid the groove in the inner face of the timber (**Figure 3.185**).

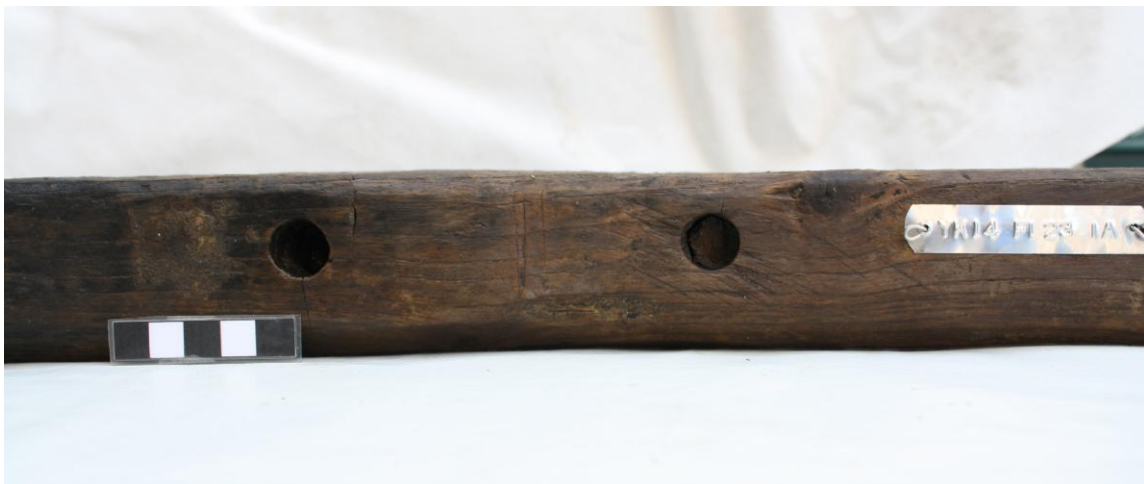
Figure 3.187: Cut and pressure marks on the inner face of FL 23 possibly related to ceiling planking or other internal timbers.

In addition to the presence of empty fastener holes inside the hull, there are also pressure marks or pitch ridges on the inner faces of some floor timbers which could have been made by ceiling planks or other internal timbers. One pressure mark occurs on FL 40 around strakes PS 1 and PS 2, and is about 7 cm wide. Another occurs on the inner face of FL 23 in the SS 1-SS2 area and is about 7.7 cm, with cut marks visible at the edges of the impression (**Figure 3.187**). If ceiling planking were used, they were likely loose planks that floated off after the sinking of the ship, or the ship's cargo was laid directly on dunnage over the ship's ballast.

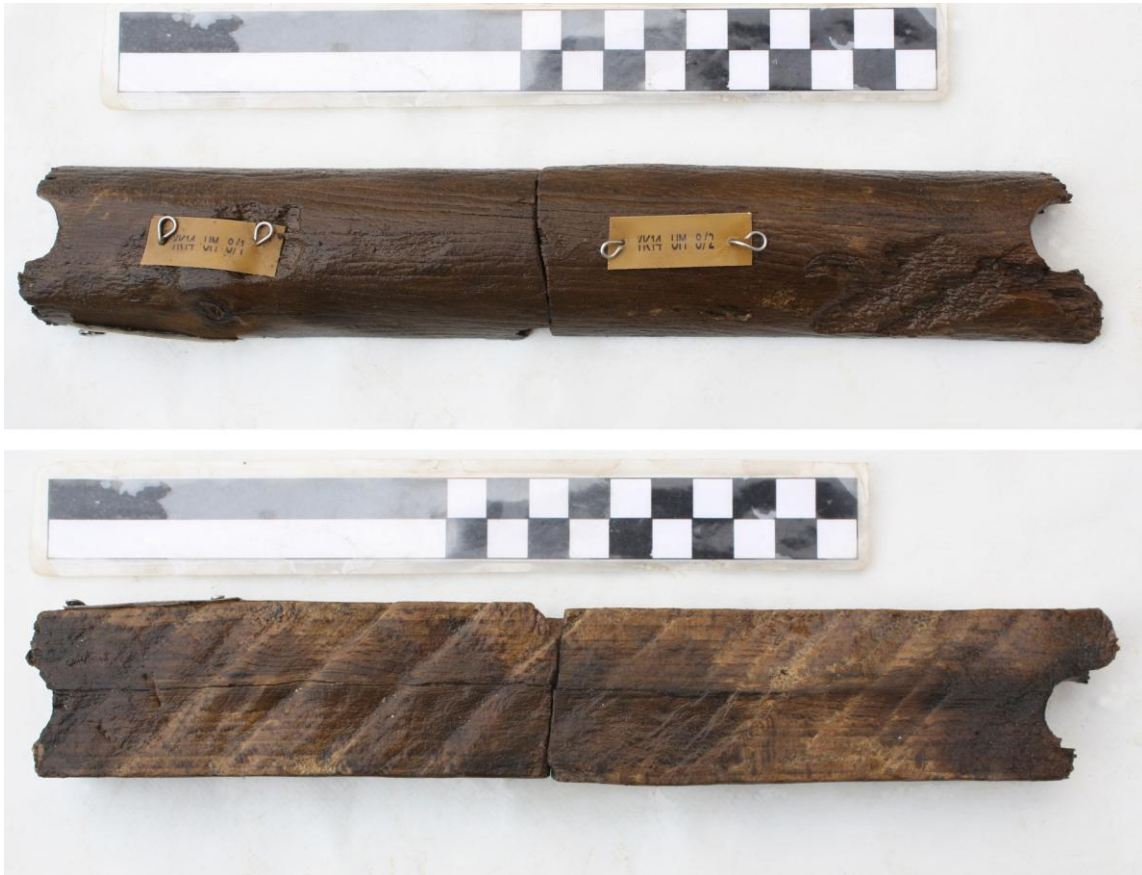
Figure 3.188: The inner and outer faces of UM 8.

UM 8 is an unusual, small timber with a sawn ‘outer face’ and rounded ‘inner face’ (**Figure. 3.188**). Several drilled holes in the piece may be for treenails, but it is too flimsy to have contributed much structural strength, and seems to be too narrow to have been from a stringer or ceiling plank. UM 8’s function is unclear; perhaps it is a repair to a cracked section in a frame (?). UM 8 was found 40-60 cm from the outboard edge of FL 36 and SS 6-3.

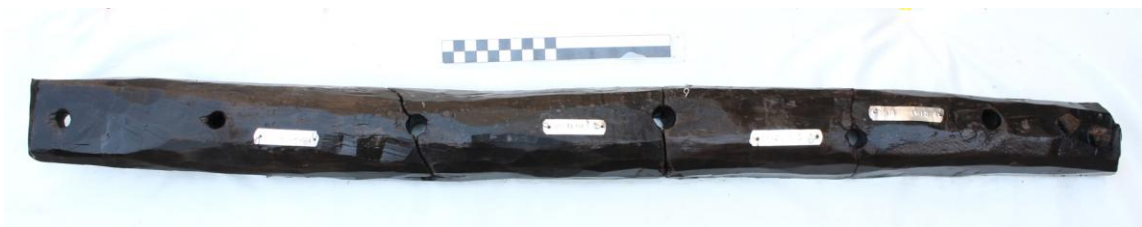
Figure 3.189: The inner face of UM 15.

UM 15 is a 95 cm-long complete futtock, adzed on all faces, and roughly chamfered on its inner face edges (**Figures 3.189**). It was found in three pieces approximately 1.6-2.0 m north of the ship's bow during digging of a ditch to drain water from the wreck site. One end of the futtock retains a shallow notch. This piece may also be a top timber, probably from the center of a ship's hull based on the angle of the outer face surface. However, the frame's unusual features as well as the fact that it was found further away from the hull than most of the other UM timbers seem to suggest that an origin from another ship is likely.

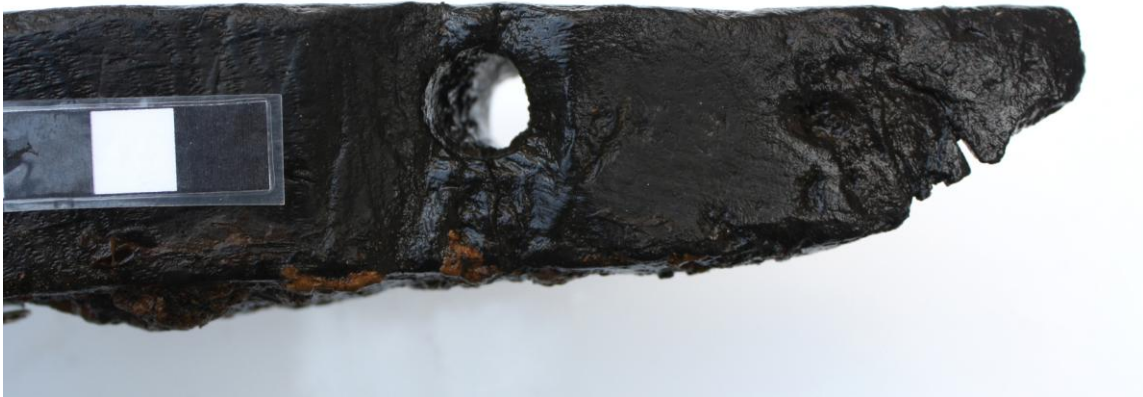
UM 5 is a 26.5-cm long section of a diagonal scarf of a plank of Sessile oak (*Quercus petraea*) (**Figure 3.190**). A countersink was chiseled out on the plank's upper edge and a pilot hole drilled for toenailing the scarf. This method of scarf fastening was not found elsewhere on YK 14. Thick pitch deposits on Face 'A' (found face-up on the site) suggest that it is the outer face of the plank. UM 5 may be the original forward end of PS 6 or a higher strake based on the location of its discovery, outboard of FL 4's starboard side.

Figure 3.190: Countersinking cut for toenailing the scarf tip of UM 5.

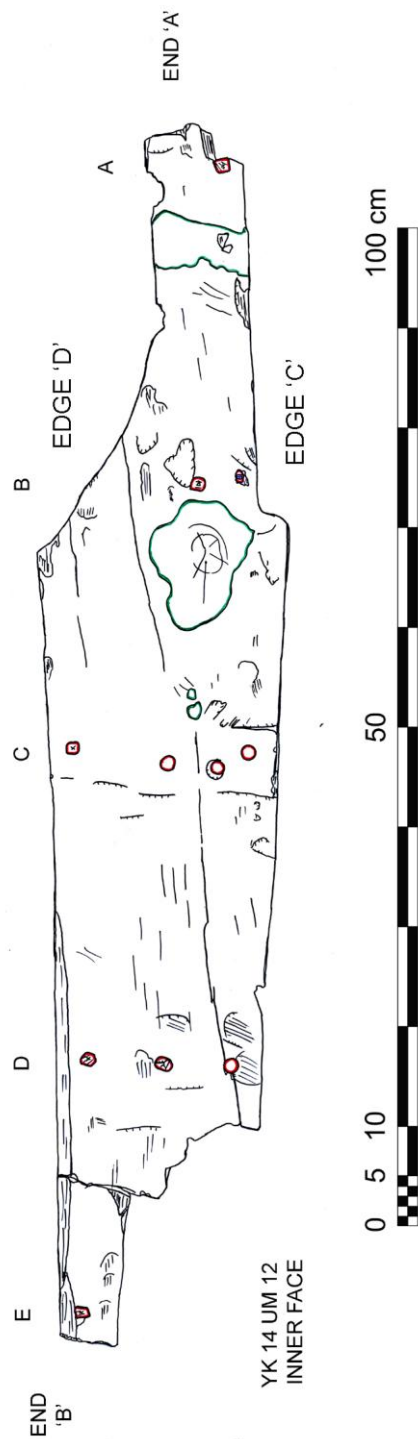
UM 12 is a hull plank fragment of Turkey oak (*Quercus cerris*) measuring 122.8 cm in length and with a maximum width of 25.1 cm (**Figure 3.191**). UM 12 was cut from a large log; approximately 95-105 rings are visible in the area of the S-scarf between frame locations 'B' and 'C'. Despite the context of the find, UM 12 was sampled for

UM 12 is unusual in having no coaks or coak holes in the plank edges, a strong indicator that it came from the upper part of the hull above the waterline. The inner and outer faces of the plank can be identified based on the heavy pitch deposits and larger fastener diameters on the original outer face. A cut raised area occurs at frame location 'C' on the inner face of the plank, a feature seen only on upper strakes PS 13 and PS 14, which were not edge-fastened in the hull. UM 12 was found under the after end of the hull on the port side. Both edges are cut, presumably for a scarf; Edge 'D' of the plank was cut for a partially preserved S-scarf 38.0 cm long, which probably had an original length of at least 60 cm. Edge 'C', the opposite edge on the same end of the plank appears to have been cut for a three-planed-scarf or an inset plank such as a stealer (closer to End 'A'). Fastener holes and pressure marks from the edges of frames indicate that five frames, almost certainly all futtocks, were fastened to the plank. The frames were fastened almost entirely with treenails driven from the outside of the hull. On the inner face of the plank at the location of Frame 'B', a caulked drilled hole with what appears to be a nail head impression was found, probably for fastening a temporary frame or prop used during construction.

Figure 3.191: Inner face of UM 12.

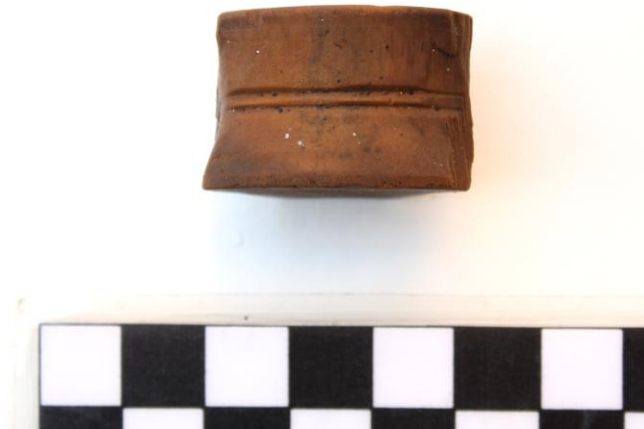
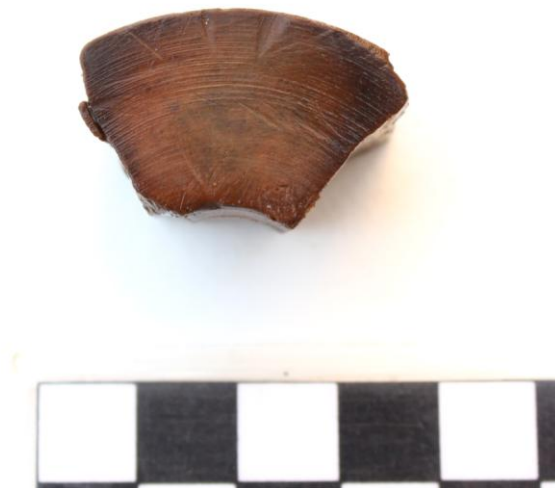
The sheave fragment (YK 14 UM 23) is 3.0 cm long and 2.0 cm thick, and is part of a sheave originally about 5.0-6.0 cm in diameter (**Figures 5.4-5**). The sheave was made from a lathe-turned piece of boxwood (*Buxus sempervirens*), and has a shallow groove cut into its circumference, with two parallel scored lines in the middle. The size and design of the sheave are similar to better preserved examples found across the Yenikapı site, and in the vicinity of YK 1, 4, and 5; several similar examples are 4.5-6.4 cm in diameter and 2-3 cm thick (**Figure 5.6**).⁴⁷³

Figure 5.4: Outer face view of UM 23.

Figure 5.5: Profile view of sheave fragment UM 23.

Figure 5.6: UM 23, cross section.

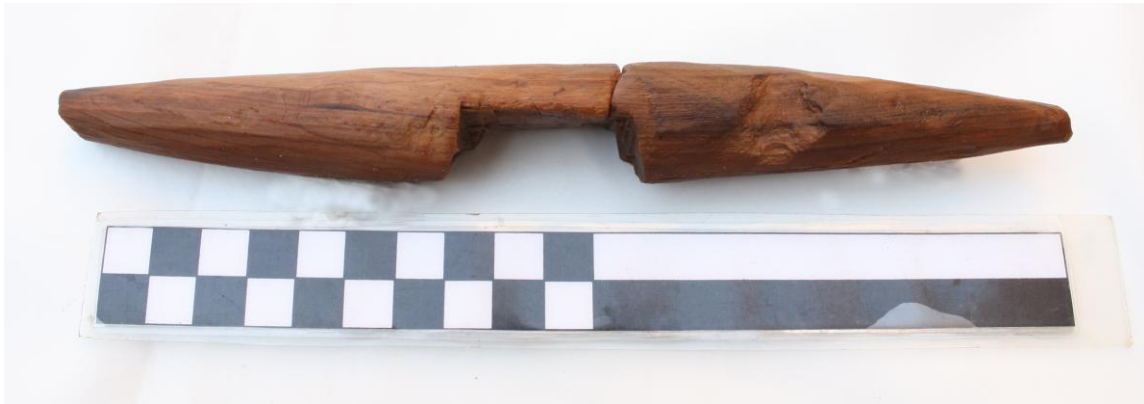
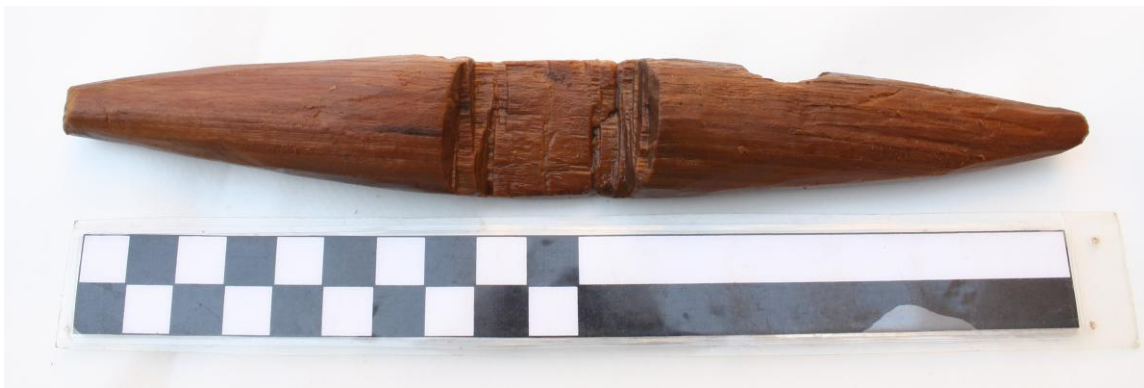
UM 24, a second wood object possibly related to the rig of the ship, was found to the west of the port side of the ship in the same stratigraphic layer during the initial excavation in April 2007. UM 24 is a toggle, 20.9 cm long, with a maximum diameter of 2.9 cm; it has tapered ends and a 3.8 cm wide, 1.3 cm deep notch cut at its center. The object was carved of oriental beech (*Fagus orientalis*) (**Figures 5.7-8**) and has some resemblance to carved toggles used for the running rigging of ships, which are fairly common finds at Yenikapı. However, these are typically made of oak rather than softer beech and are of a more robust design than UM 24 (**Figure 5.9**). UM 24 may, therefore, have had a different function than as a toggle used in a ship's rigging.

Figure 5.7: Beechwood toggle found under the hull of YK 14. Although its dimensions are typical of other toggles found at Yenikapı, the design of this toggle with a notch in the middle is different from that of other rigging toggles found on the site. It is possible that it may be unrelated to rigging.

Figure 5.8: YK 14 UM 24: a view of the notch in the center of the toggle.

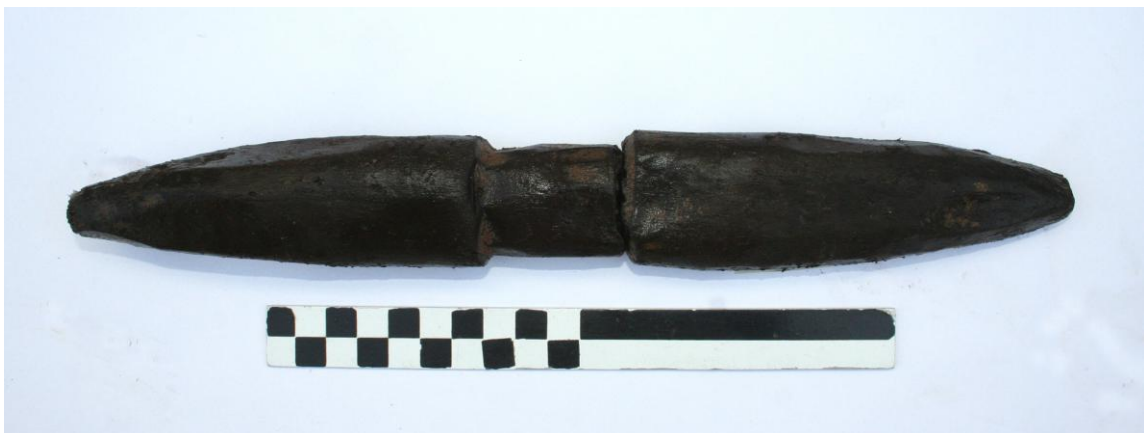
Figure 5.9: A typical oak rigging toggle found under the hull of YK 24 (tenth century).

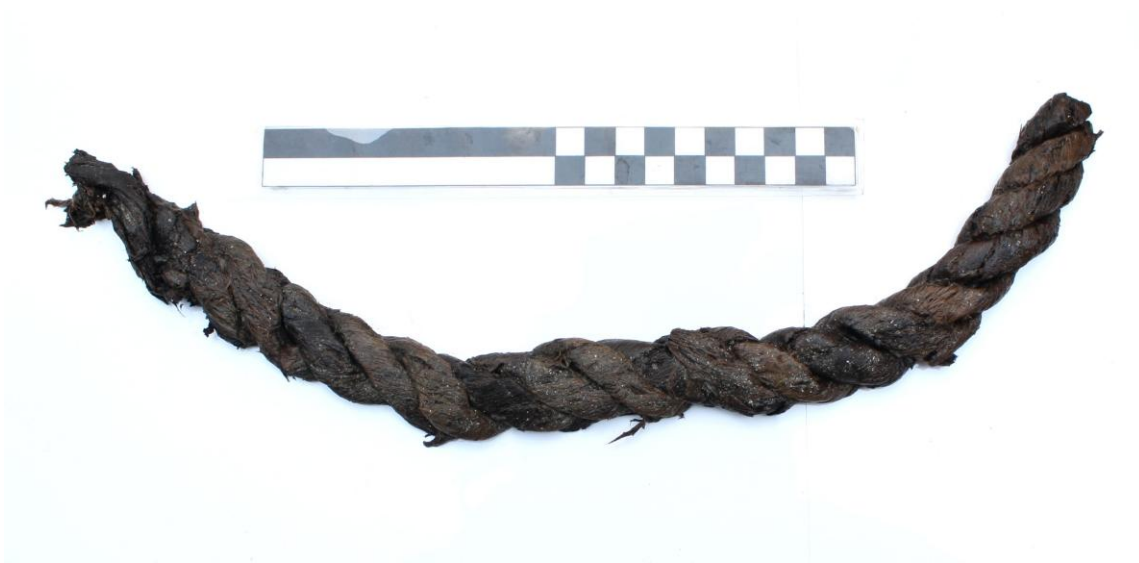
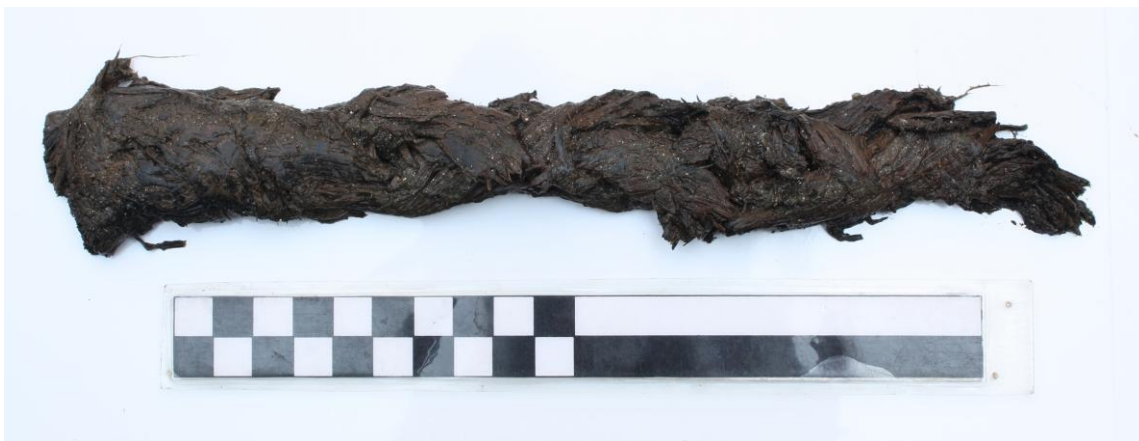
Two rope fragments found in the excavation area, which were approximately 2.3-2.5 cm in diameter, would have fit well in the block from which the UM 23 sheave fragment came, and are of a similar diameter to ropes found on other shipwrecks.⁴⁷⁴ The ropes are 3-strand hawser laid ropes with a ‘Z’ twist.⁴⁷⁵ The better preserved example is Fragment #1, an approximately 50 cm-long section found 10-50 cm south of the aft end of the aft keel timber (Keel 1) (**Figures 5.10-11**). Fragment #2 was found between separated strakes SS 6 and 7 in the area of FL 29-31. This rope fragment was more poorly preserved, and the strands were more difficult to distinguish, but it was made from the same material as rope Fragment #1. It was originally about 48 cm long, but partially disintegrated during its excavation; a main portion with a length of about 25 cm survived, and most of the rope fibers were recovered and bagged separately.

Figure 5.10: Rope fragment #1 after cleaning and sampling.

Figure 5.11: The best preserved section of Rope fragment #2.

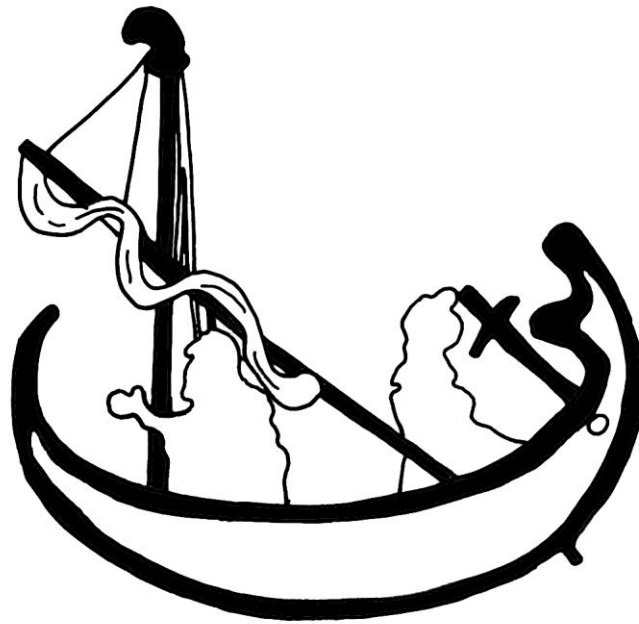
Figure 5.20: A small Byzantine lateen-rigged vessel depicted in an eleventh-century manuscript from the Church of Giorgio del Greci, Venice (lectionary folio 63 ro). Note the pair of halyards, particularly where they emerge from the hook-shaped mast head, and the furled sail (After Martin 2001, 61, Fig. 35).

⁵⁶⁵ This interpretation is favored by C. Pulak (personal communication) and could account both for the position of the halyards shown in the vessel shown in Figure 5.20 (supra n. 483 for the alternate interpretation by Martin and Pryor).

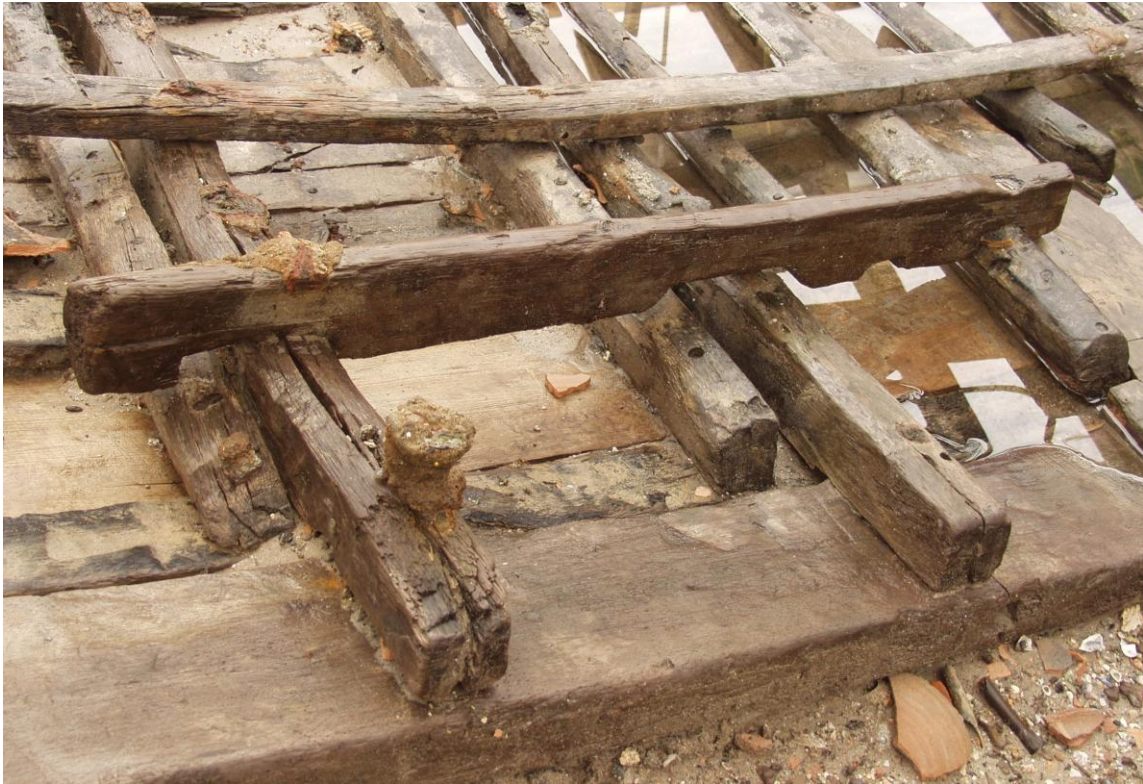
Figure 5.30: Possible cleat on YK 1. Note the notches cut into the outboard side of the timber (facing downward in the photograph).

horizontal timber, probably added during the refit of the hull (**Figure 5.30**). Notches cut into the timber's outer face could perhaps have been used for securing lines.

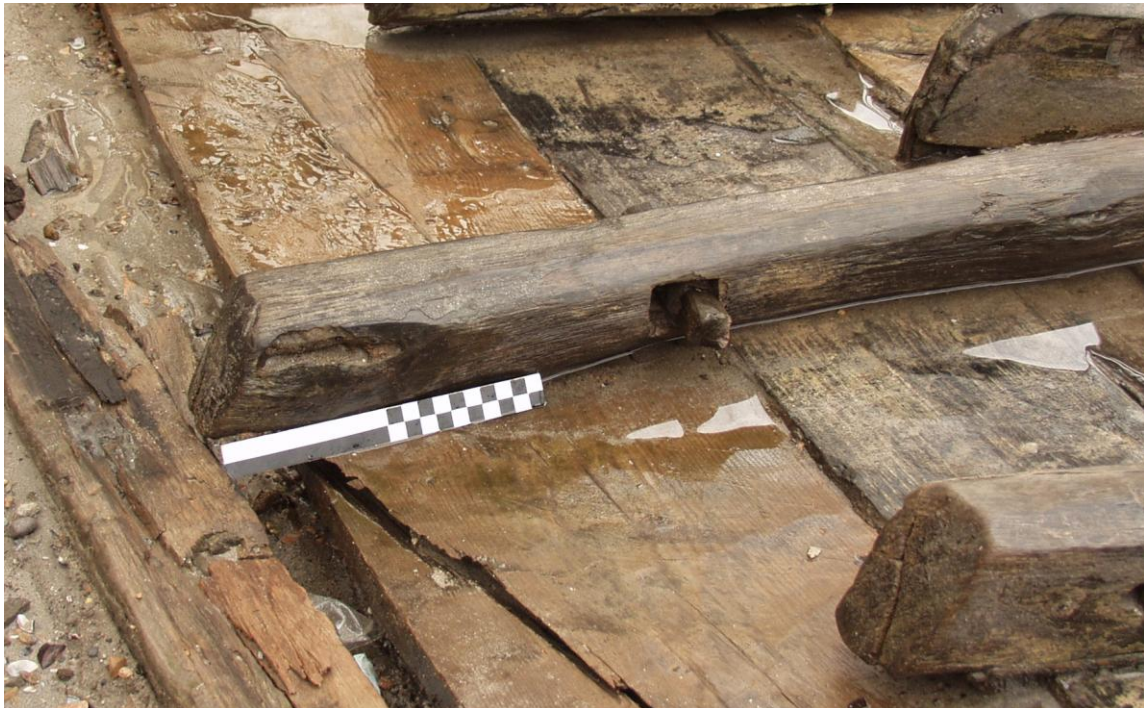
Figure 5.31: Futtock timber from YK 1 with a large peg driven through a fore-and-aft-oriented hole in the upper end of the timber. This feature may have been used as a cleat or belaying pin.

Other features on the same ship may have served as cleats or locations for belaying rigging lines. Square mortises were cut through the forward and aft faces of three futtocks at their upper ends; a wooden peg was driven through one of the holes at futtock F 16 (**Figure 5.31**).⁶⁰⁷ An identical design was used for a cleat or belaying pin on the

⁶⁰⁷ The mortise with the peg driven through it was found on futtock F 16, a 'secondary' futtock installed after the overhaul of the ship. The two other mortises are in futtocks F 17 and F 24, which are 'primary'

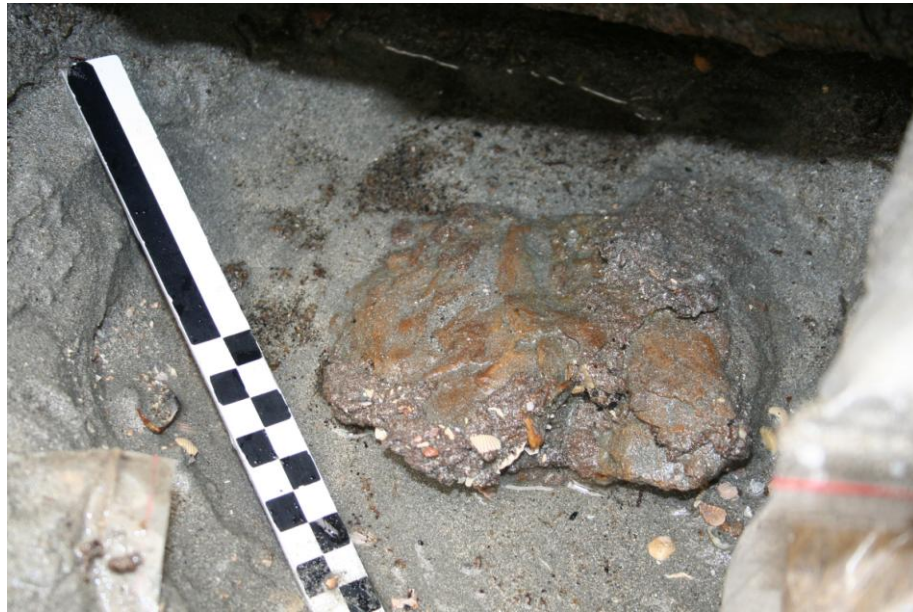
Figure 6.2: Large clump of pitch (YK 14/16) found under the hull of YK 14 during excavation.

⁶⁴⁸ Two smaller clumps between 6 and 10.5 cm in diameter were found near the shipwreck as well. The type of hair has not yet been identified.

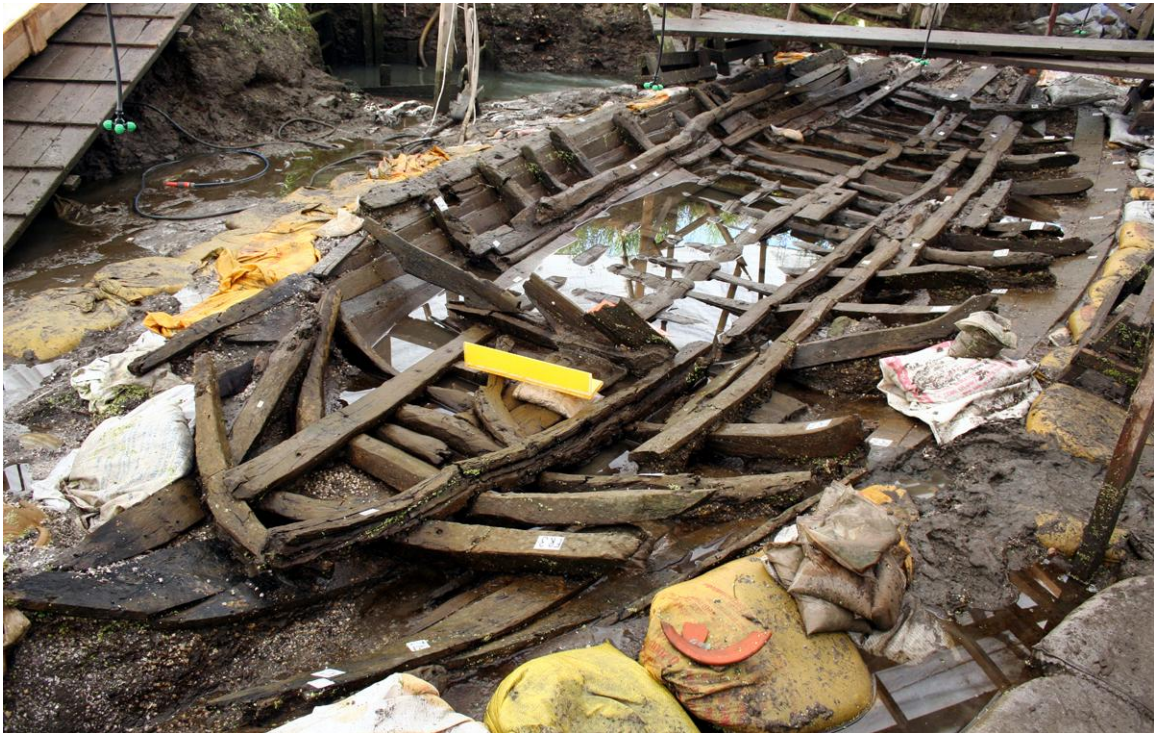
Figure 7.2: The YK 11 shipwreck, after its initial excavation in the spring of 2008.

YK 11, excavated in the summer and fall of 2008, is a small merchantman discovered in 2006 towards the western end of the Marmaray excavation site (**Figure 7.2**). This area was one of the first sections of the harbor to suffer the effects of silting from the Lykos River; the Late Roman and Byzantine-period deposits here consist of dark, anaerobic mud with shell inclusions mixed with refuse and artifacts dumped in the harbor. Organic remains in these deposits were very well preserved. Pottery and other artifacts in the stratigraphic layer of YK 11 and inside the vessel indicate an early seventh-century date for the ship.⁷¹⁴

The bottom of the ship and one side of the hull was preserved to just above the waterline. The shipwreck covered an area of approximately 9.5 x 4 meters, while the ship itself has been reconstructed as about 12 meters in length and 4 meters in beam.⁷¹⁵ Teredo worm holes in the upper section of the hull indicate that the ship was exposed for a significant period of time after sinking, probably after its abandonment as a derelict.⁷¹⁶ Despite this, the hull timbers were well preserved. Surviving hull elements include planking, two wales, frames, and a three-part keel of Turkey oak (*Quercus cerris*) connected with keyed hook scarfs; internal timbers include stringers, ceiling planking, and part of a bulkhead partition at the ship's stern. Almost all of the ship's planking and

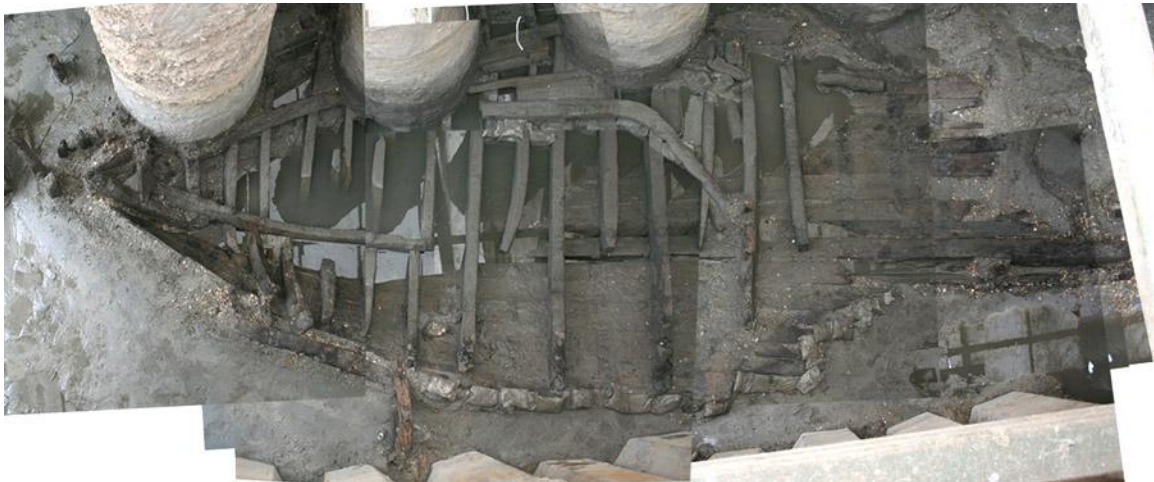
Figure 7.3: Photomosaic of the YK 23 shipwreck by S. Matthews. Concrete pilings for the retaining wall are visible at the top of the photomosaic.

YK 23 was discovered in the spring of 2007, when it was damaged by a machine boring holes for concrete pilings to construct a retaining wall along the eastern side of Namik Kemal Street (**Figure 7.3**). Although numerous fragments of the hull were recovered from the sediment removed by the boring machine, the bore holes were subsequently filled with concrete, which left four 1.5 meter-diameter concrete pillars in the side of the

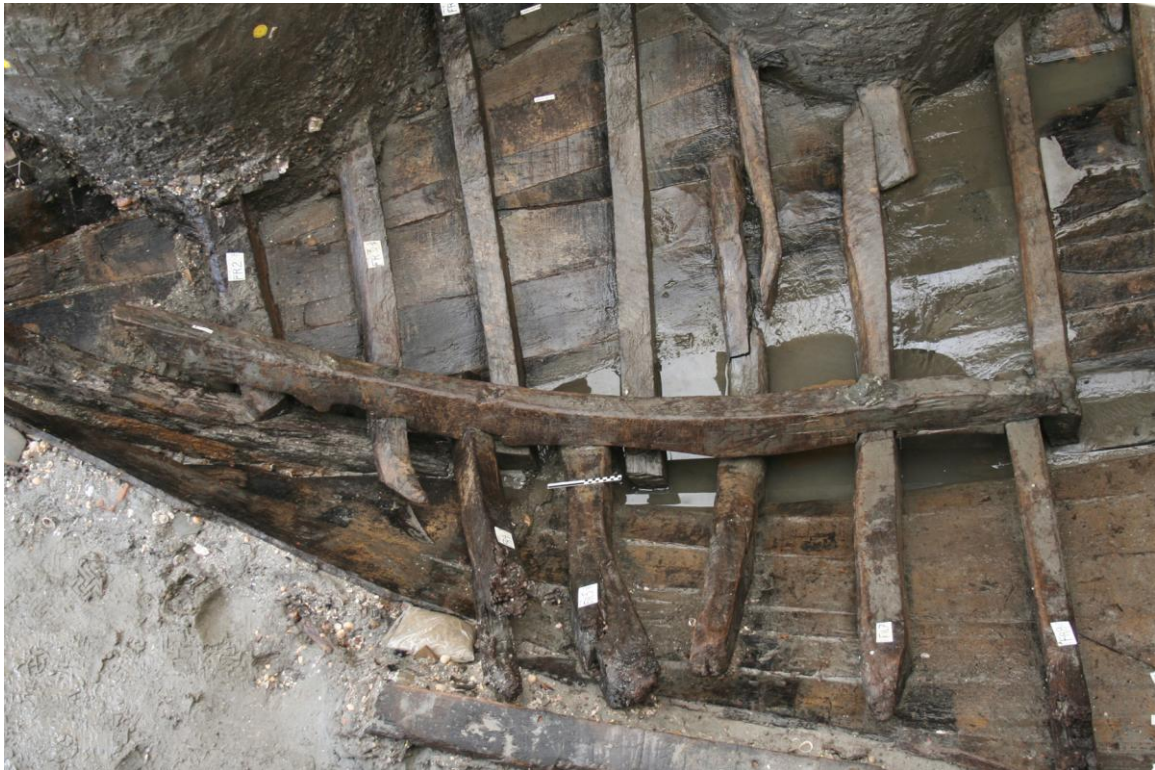
Figure 7.4: Longitudinal sternsom (?) fastened to the inner faces of the frames in the better-preserved end of YK 23.

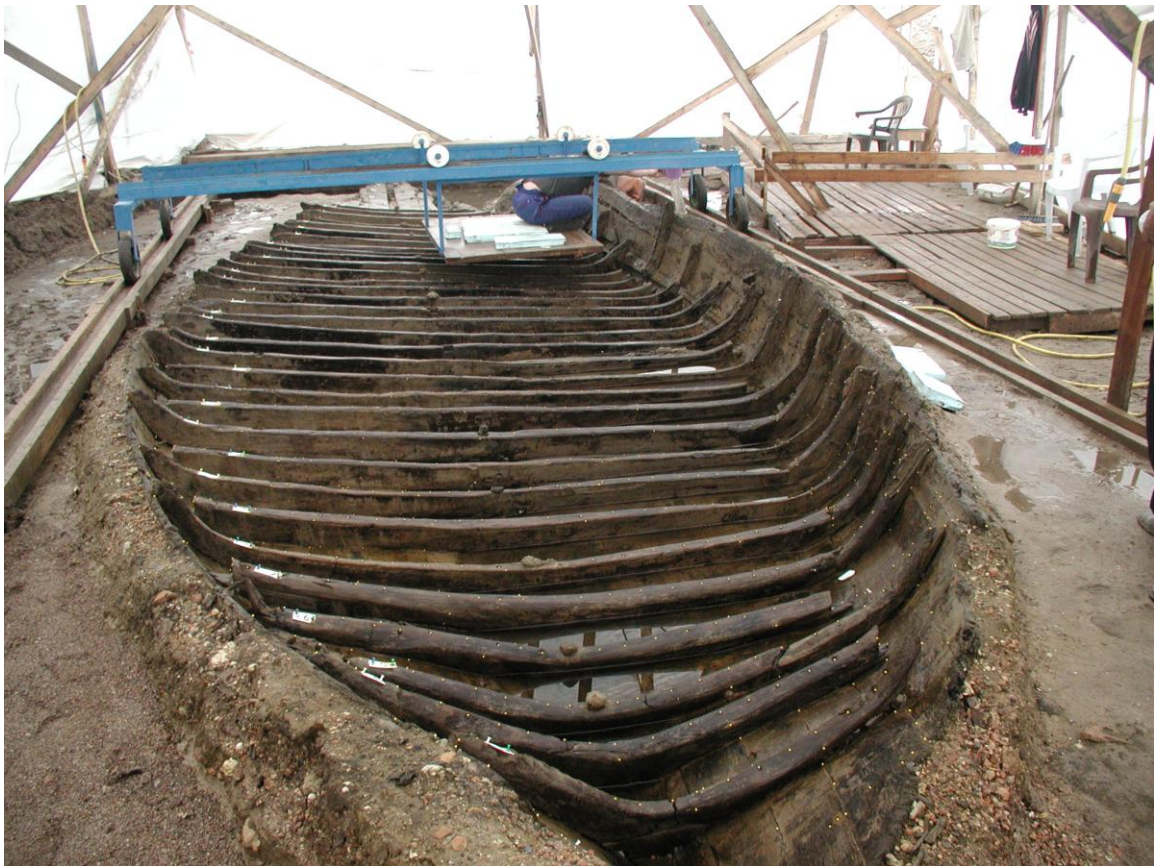
Figure 7.6: YK 5, a cargo vessel dating to the late tenth century, during excavation in April 2006.

YK 5 is a well-preserved, medium-sized roundship discovered near the eastern end of the site in late 2005 and excavated in the summer and fall of 2006 (**Figure 7.6**). The ship's cargo and equipment was probably dispersed and salvaged aside from several iron objects found in the hull. YK 5 was found in a sandy layer partly covering one side of the galley YK 4, and dated by artifact finds and radiocarbon dates to the late tenth century C.E.⁷²³ The ship's position, as well as the lack of shipworm damage in the timbers of both shipwrecks, seems to indicate that YK 5 may have collided with YK 4
